**DEPARTMENT OF TRANSPORTATION**

Contract #: 04-0120F4Cty: SF/ALA Rte: 80 PM: 13.2/13.9File #: 1.28**WELDING INSPECTION REPORT****Resident Engineer:** Casey, William**Address:** 333 Burma Road**City:** Oakland, CA 94607**Report No:** WIR-027751**Date Inspected:** 12-Jun-2012**Project Name:** SAS Superstructure**OSM Arrival Time:** 700**Prime Contractor:** American Bridge/Fluor Enterprises, a JV**OSM Departure Time:** 1730**Contractor:** American Bridge/Fluor Enterprises, a JV**Location:** Job Site**CWI Name:** As noted below.**CWI Present:** Yes No**Inspected CWI report:** Yes No N/A**Rod Oven in Use:** Yes No N/A**Electrode to specification:** Yes No N/A**Weld Procedures Followed:** Yes No N/A**Qualified Welders:** Yes No N/A**Verified Joint Fit-up:** Yes No N/A**Approved Drawings:** Yes No N/A**Approved WPS:** Yes No N/A**Delayed / Cancelled:** Yes No N/A**Bridge No:** 34-0006**Component:** Tower Component**Summary of Items Observed:**

**Electroslag Weld Excavation**

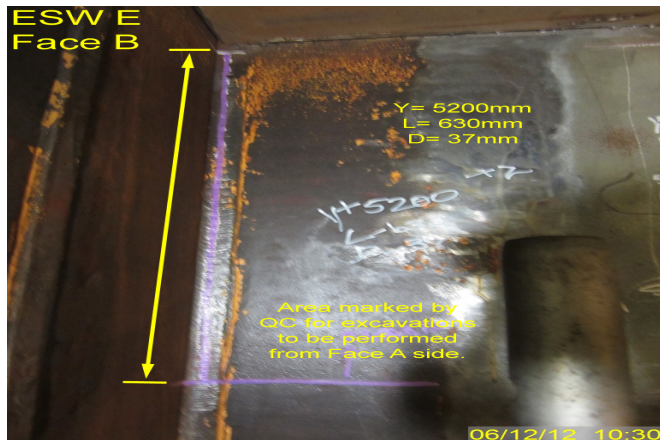
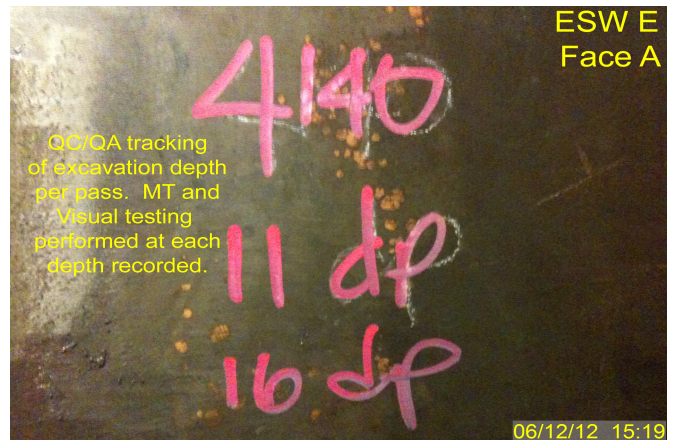
This QA observed ABF/JV welding personnel Xiao Jian Wan #9677 excavation of an Electroslag Weld (ESW) previously Ultrasonic Tested (UT) by Quality Control (QC) technicians.

The UT discovered indications were found to be oriented in the longitudinal position. The indications were found to range from rejectable per AWS D1.5 Table 6.4 to within the recordable criteria to be subject to further Radiographic Testing (RT).

The weld being excavated is designated as "ESW E" and was excavated at multiple locations throughout the "Y=4140mm" to 9m elevation. These excavations are ongoing and have yet to receive final measurements for depth, width, and length.

The carbon arc gouging process, as well as machine grinding, were used to excavated approximately 2mm-5mm at a time. In between excavation passes both QA and QC performed Magnetic Particle Testing (MT) and photographed any discovered indications.

At this time of excavation this QA has not observed any indications using either MT or visual testing methods.
